DEPARTMENT OF TRANSPORTATION

Quality Assurance and Source Inspection

Contract #: 04-0120F4Cty: SF/ALA Rte: 80 PM: 13.2/13.9File #: 1.28**WELDING INSPECTION REPORT****Resident Engineer:** Casey, William**Address:** 333 Burma Road**City:** Oakland, CA 94607**Report No:** WIR-028812**Date Inspected:** 04-Dec-2012**Project Name:** SAS Superstructure**OSM Arrival Time:** 700**Prime Contractor:** American Bridge/Fluor Enterprises, a JV**OSM Departure Time:** 1730**Contractor:** American Bridge/Fluor Enterprises, a JV**Location:** Job Site**CWI Name:** See below.**CWI Present:** Yes No**Inspected CWI report:** Yes No N/A**Rod Oven in Use:** Yes No N/A**Electrode to specification:** Yes No N/A**Weld Procedures Followed:** Yes No N/A**Qualified Welders:** Yes No N/A**Verified Joint Fit-up:** Yes No N/A**Approved Drawings:** Yes No N/A**Approved WPS:** Yes No N/A**Delayed / Cancelled:** Yes No N/A**Bridge No:** 34-0006**Component:** OBG**Summary of Items Observed:**

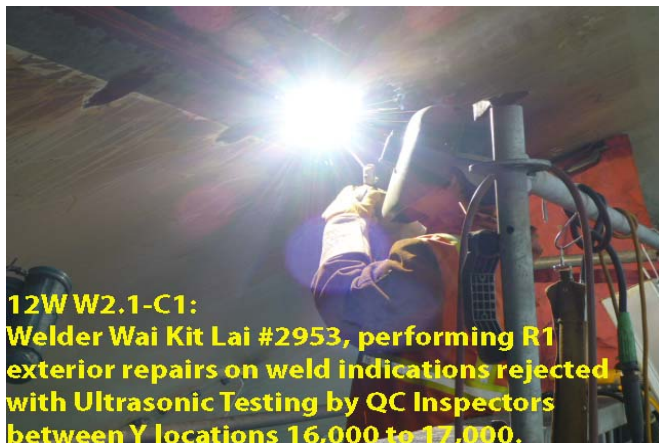
This QA witnessed QC Patrick Swain perform Hardness Testing at the same locations mentioned above.
(Hardness Testing results left in the tester as per Engineers request)
